# Service Bulletin

Bulletin No: 31 001 02 (043)

## BMW Motorcycles

**Subject:** Technical Action: Replacement of bolt in the fork stabilizer - F 650 Dakar models only.

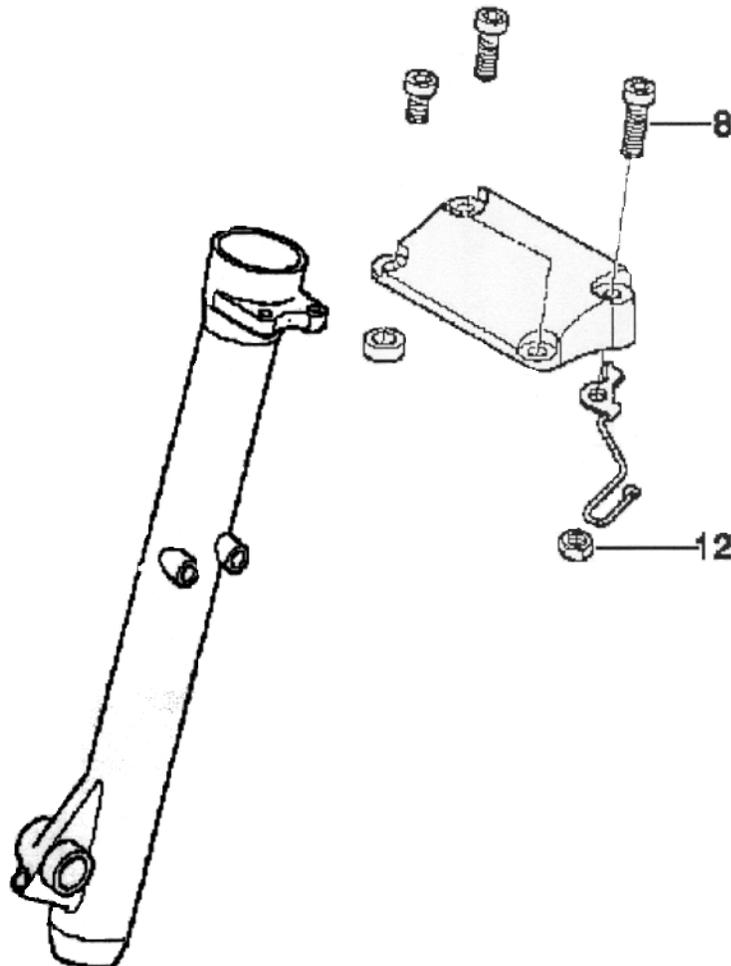
**Details:** We have been notified by Showa, the manufacturer of the front forks for the F 650 Dakar model, that one of the four mounting bolts, attaching the fork stabilizer to the fork legs is incorrect.

The shank on the incorrect bolt is too long and may not hold properly, even though it was installed to the correct torque.

It is possible that the brake hose holder that is held in place by this bolt may work loose over time.

**Service Solution:** Remove the mounting bolt (#8 in the illustration below) replacing it with the M8x40 bolt included with this bulletin. Tighten this bolt to 20 Nm.

Install the brake hose holder and securing nut (#12 in the illustration below). Use Loctite 2701 and a tightening torque of 8.5 Nm for this installation.
