Service Bulletin

Bulletin No: 16 001 02 (010)

BMW Motorcycles

Subject: Charcoal canister inspection - F 650 CS

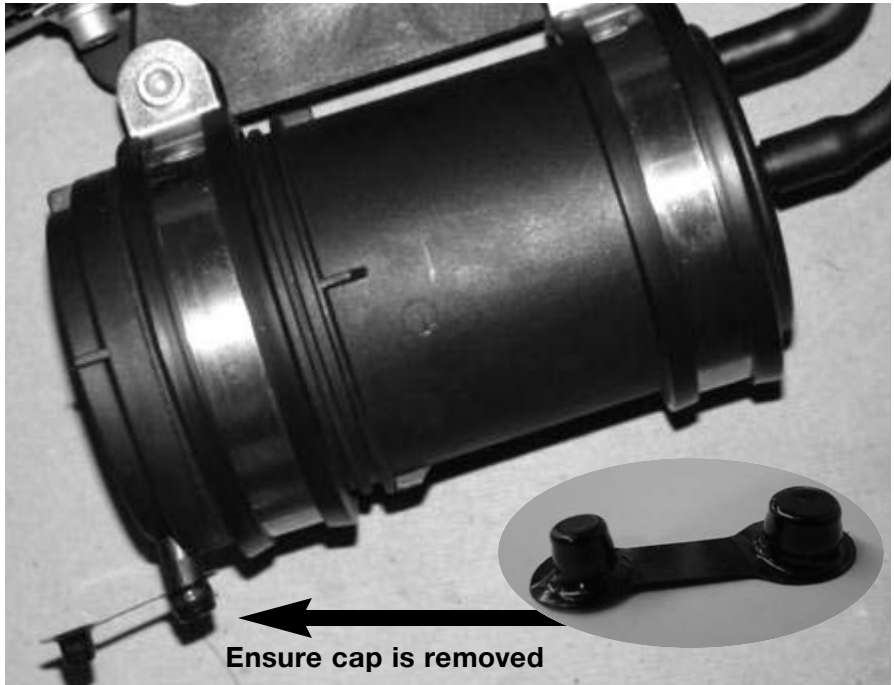
Details: On early production examples of the F 650 CS model, the possibility exists that a plastic protective cap, used to preserve the integrity of the charcoal canister during shipping, was not removed during final motorcycle assembly. If the cap is not removed, this could lead, in some circumstances, to a rough running engine.

The photo below illustrates the charcoal canister with the plastic cap in place.

Aftersales Solution: During the set-up and PDI, or a routine service, inspect the charcoal canister and remove the cap if necessary.
