Service Bulletin

Bulletin No: 46 004 04 (024)

BMW Motorrad USA

Topic: Center stand of the F 650 GS model when fitted with the lowered suspension option.

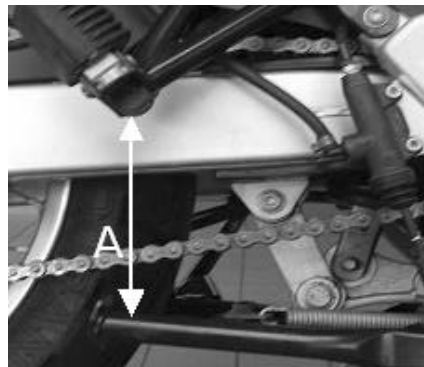
Picture 1

Distance "A" : Clearance between right footrest and center stand tube.

(**A**<170 mm or 6.69 inches)
Center Stand is good and does not require replacement.

(**A**>170 mm or 6.69 inches)
Center stand needs to be replaced.

Service Solution: F 650 GS models within the following VIN range, that are equipped with the lowered suspension option, will need to be checked as described below the next time that they are brought in for service. New center stands will need to be installed on motorcycles not meeting the required specifications.

Work Package #2: Measure center stand distance. Distance is outside of specification. Replace center stand.
